TECHNICAL INFORMATION

Automatic Temperature Control Fault Display Correction

No: 82/01/03/NAS
Ref:
Issue: 1
Date: 27 February 2004

Range Rover (LP) up to 2A427128

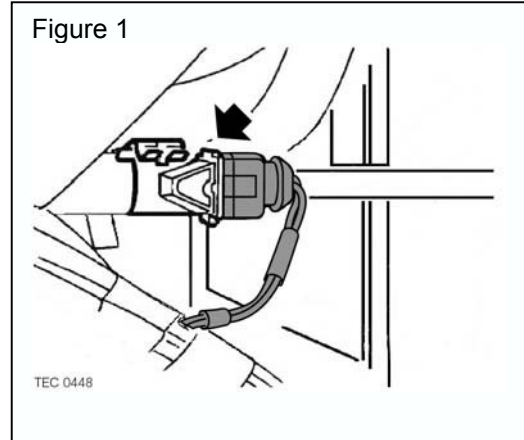
Figure 1

When the coolant temperature reaches 97 C (207 F) , and stays at or above that temperature for ten minutes, the Automatic Temperature Control (ATC) diagnostic system will illuminate the 'handbook symbol' on the ATC display. The diagnostic fault code in the ATC panel software is set too low for normal vehicle operating conditions in very hot climates.

1. Refer to RAVE Workshop Manual section 82.20.94 and perform steps 1-5 to gain access to the heater temperature sensor.
2. Disconnect the heater temperature sensor multi-plug. (Arrowed in Figure 1).
3. Connect the link lead (YMQ501010) to the heater temperature sensor and electrical harness (Figure 2).
4. Reverse the Workshop Manual section 82.20.94 removal procedures steps 1-5, and install the removed components.
